Conservation Project: Central Station Clock Tower

NSW Railway Conservation Guide

March 2013

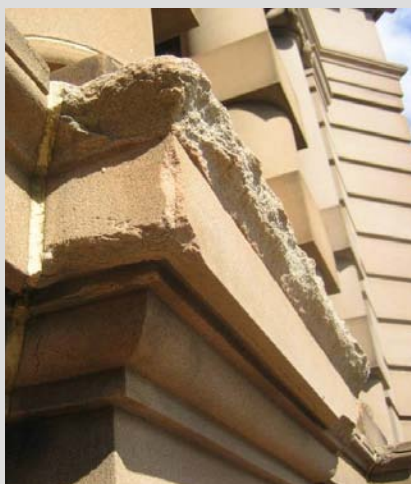
Stone defects to cornices of Clock Tower.

The elements of the tower which showed the most levels of deterioration when inspections were undertaken were the upper dome, top sections of the tower such as the large-scale decorative urns, projecting stonework such as cornices, string courses, balconies and the large statues around the tower clock-face. Each of the 3500 stone blocks on the outer face of the tower were labelled, inspected and documented. This included: stone number, stone location, stone finish, type of conservation action required, physical size of the repair, and photograph of defect.

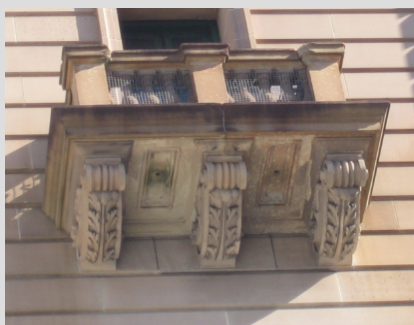
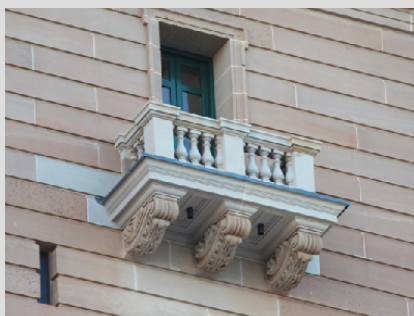
The Clock Tower's Juliet balcony before and after restoration. Light coloured stones are those that have been replaced or indented, including the 4 ton floor slab stones.

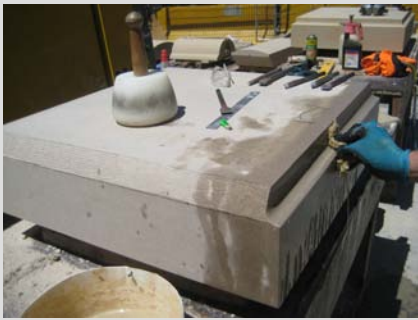
The replacement stone for the Clock Tower's Juliet 4 ton floor slab.

Whole blocks of badly deteriorated stone masonry were replaced with new blocks of compatible natural stone. New stone was carefully selected to match the original Sydney sandstone and was sourced from the NSW Government store of 'Pyrmont Yellow-Block McCaffreys' stone. Some 358 stones were replaced with the largest being the Clock Tower's Juliette balcony protruding floor slabs that weighed around 4 tons each.

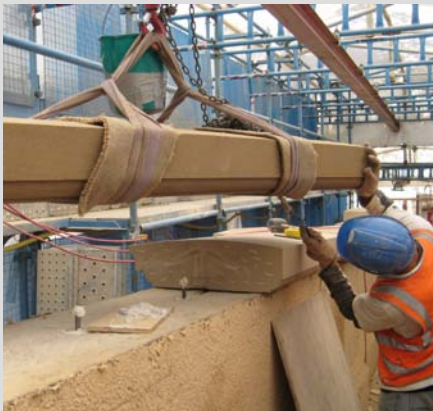
Stone block replacement for wall cappings.

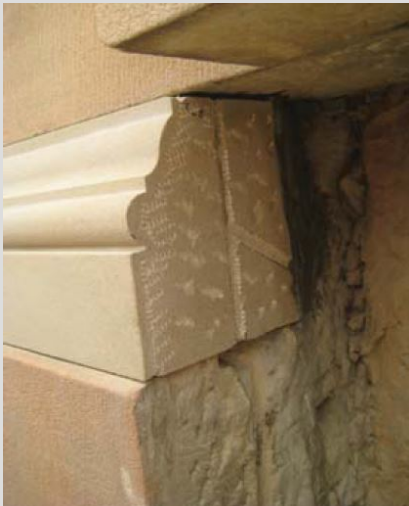
New indented stonework.

Where stone is badly deteriorated and needs replacing, but the location of the stone is such that there are stones above it and it cannot be lifted out, then the stonework needs to be 'indented'. Indentation is the process of replacing only the outer section of the stonework.

The indented stone section needs to be of sufficient depth to allow for pinning to occur. Stainless steel is usually used for pinning. Indented stones should not be too thin, but generally have a minimum of 110 to 150mm depth. Where the stones project such as cornices or string courses, the depth of indent should be at least equivalent to the depth of projection. This latter indent geometry is crucial when earthquake or seismic concerns are considered, this ensures the indent is not totally relying on the stainless steel pins but the natural balancing of 'projecting' to 'embedded' stonework.

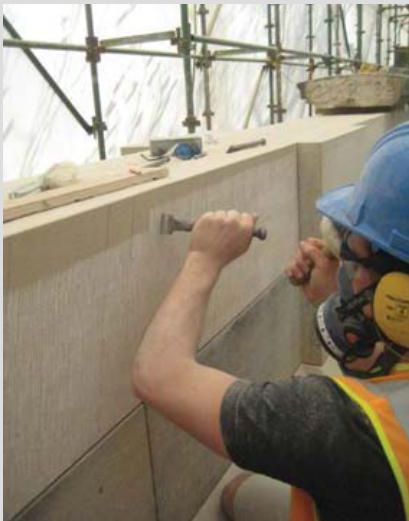
Stonework retooled after indenting.

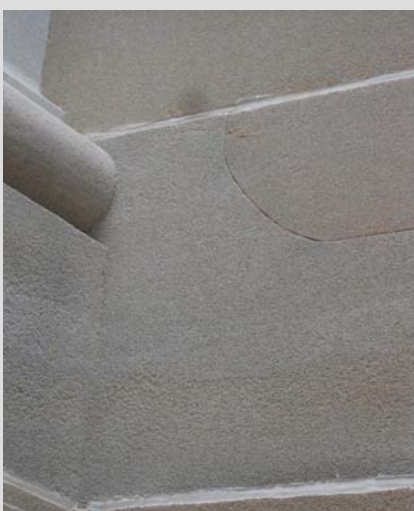
Hairline indent for small section of existing stone block.

When only a section of a stone block requires being replaced, then indenting or replacement methods can be replaced by smaller 'hairline' indents. These are similar to normal indents except much smaller and with very fine joints. To ensure these smaller indents are safe, modern practice, especially due to seismic concerns, requires the stones to be pinned. The advantage of hairline indents in lieu of 'synthetic repair' techniques (see below) is that they have decades long lasting qualities similar to the parent stones.

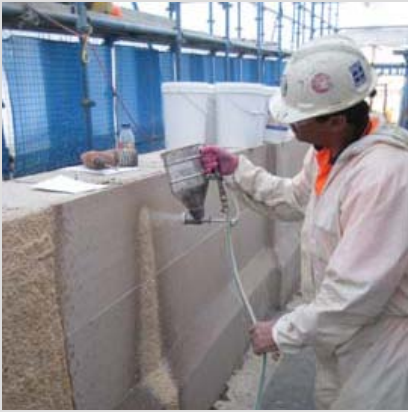
Paper-mache poultrice being applied to ramp up to Clock Tower.

At Central, pollutants were removed using a specialised poultrice where there was evidence of areas of salt activity and delamination/scaling of the outer surface to the stone. After a poultrice is applied and as the wall dries, water-carrying salts evaporate at the surface depositing salt in the sacrificial paper-mache material. Natural drying processes ensure that salts crystallize near the outer surfaces and the applied poultrice layer acts as a sacrificial layer where salts are deposited. When the poultrice dries out the salt-ridden poultrice can be removed.

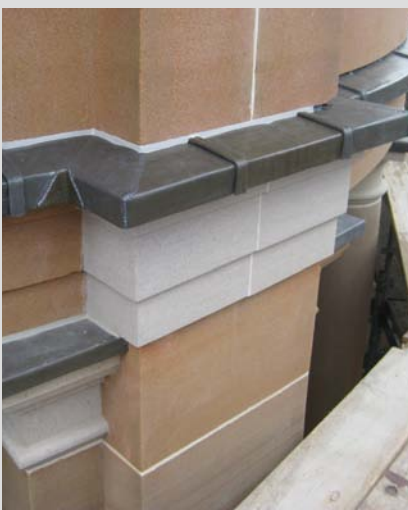
Protection of projecting stones through lead coverings.

Lead coverings were introduced on top of projecting cornices, balconies, around the top of the clock faces and above statue heads. The use of lead in these areas will assist in diverting water away from the structure and prolong the life of the existing stone. These elements have a minimal impact on the overall integrity and aesthetics of the original structure. An exception to this is the original dome of the tower, which was originally constructed in sandstone with just a copper crown to support the flagpole. The constant exposure to weathering of this stone element over time had caused considerable deterioration as well as water egress to the interior of the structure also impacting on the internal concrete slabs.

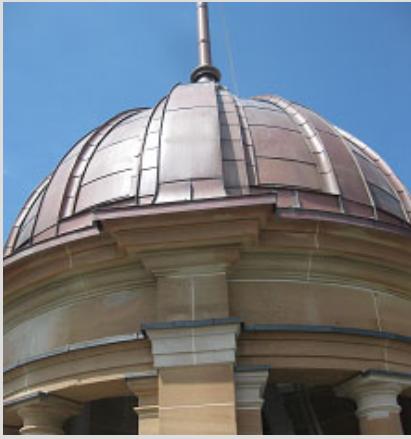
Introduced copper dome covering to protect original fragile stonework.

Reconstructing the dome in sandstone was considered as an option, however, due to ongoing weathering and exposure, the dome would have required further and constant repair in future years. As such, the option was put forward to clad the entire dome in copper, reflecting its traditional use in other domed grand public buildings in Sydney. The use of copper provides a suitable balance between practical conservation and retention of heritage fabric, by allowing the conservation of the original sandstone fabric in situ as well as assisting in the ongoing maintenance of the structure.

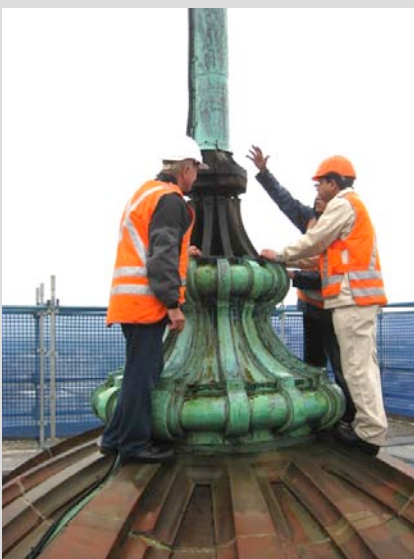
The reconstructed flagpole being inspected (above) and being craned into place (right).

In addition to the stoneworks, an example of this approach was the restoration of the 90 year old flagpole which was carefully taken down in order to remove parts of its rusted metal core. The works included treating the deteriorated steel of the pole, and only replacing sections of the metal that had structurally failed, ensuring the ongoing integrity of this element as well as conservation of original material. The restored 9.7m high flag pole was then craned back on to the top of the dome.
